BEAUMONT INSPECTIONS, LLC. WESTERN NORTH CAROLINA

RESIDENTIAL REPORT

Hendersonville , NC 28739

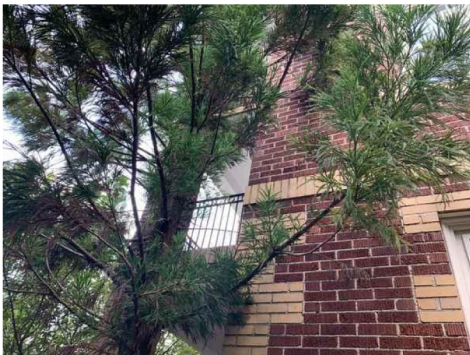
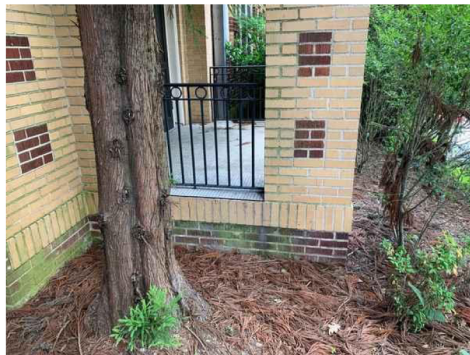
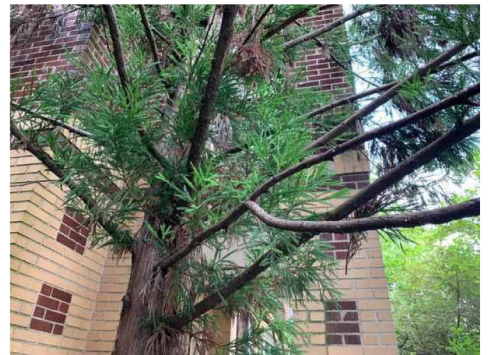
2.2.1 Vegetation

VEGETATION TOO CLOSE TO STRUCTURE

Trees and or bushes are growing too close or are in contact with the exterior of the structure. Vegetation that is too close to the building can trap moisture and prevent adequate ventilation. Lack of air circulation can encourage the development of biological growth that can accelerated the rate of damage. A qualified landscape contractor should be consulted to remove excessive vegetation.

Contact a qualified landscaping contractor

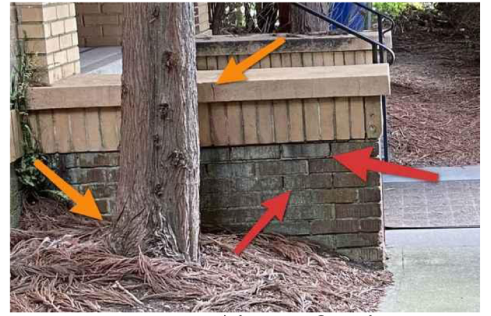
Entry Steps to Building Left Side

WALKWAY ROOT DAMAGE

BUILDING ENTRY

A section of the front concrete steps and brick side walls have settled uneven with the rest of the structure. This creates a source of water infiltration into the brick veneer. Recommend a qualified masonry contractor further evaluate to determine the best way to level the walkway and fix the brick mortar.

Contact a qualified concrete contractor.

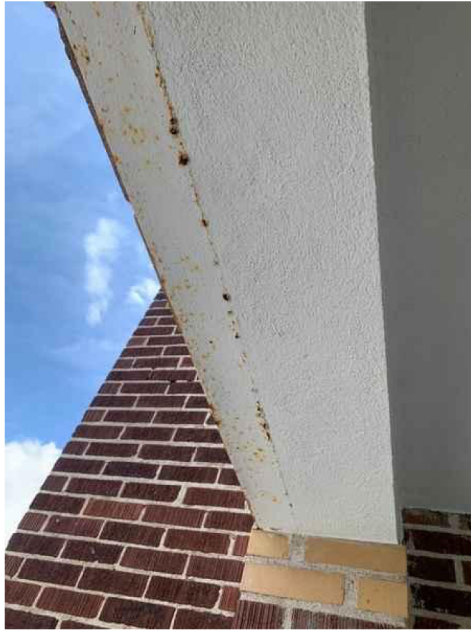
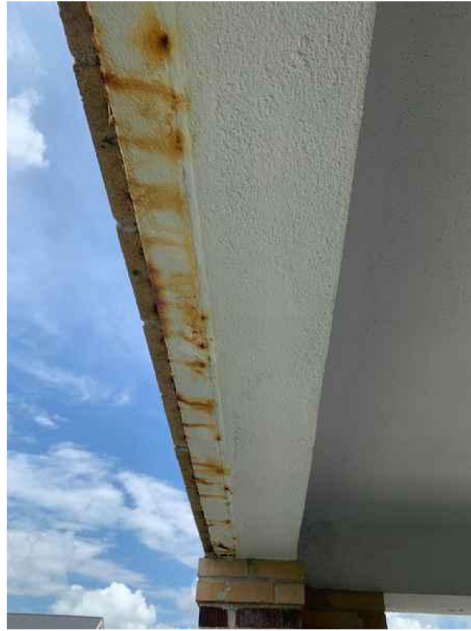
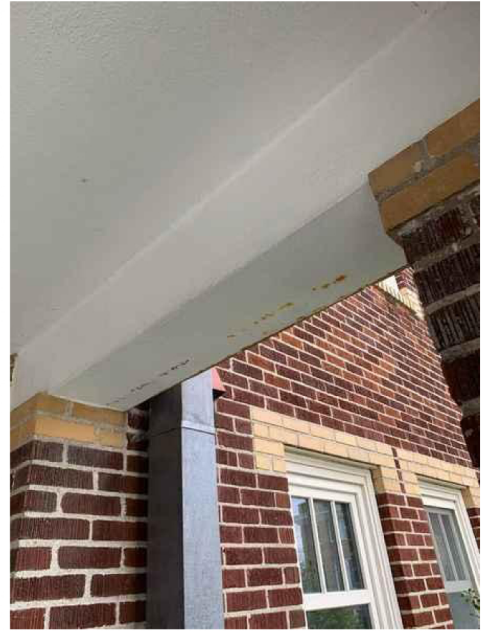
3.1.2 Brick Veneer

STEEL LINTEL RUSTING

COVERED PORCHES

Water penetration at the brick veneer over the exterior porch openings are showing rusted delaminating of the steel. A thicker portion of grout is visible in the middle and may be an indication of a previous patch. A qualified masonry contractor should be retained to determine repair steps.

Contact a qualified masonry professional.

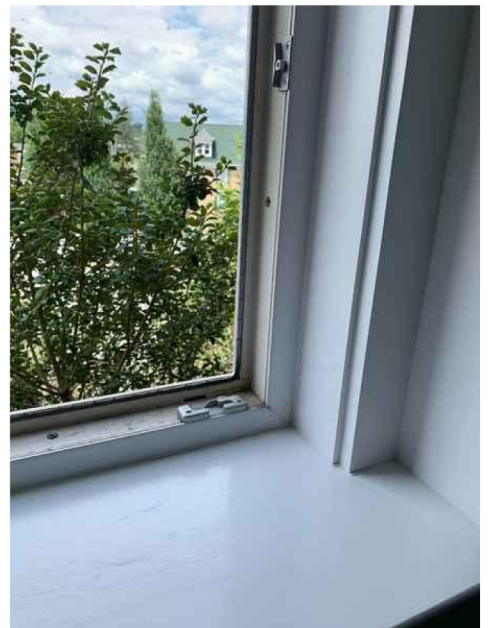
Master Bedroom Closet Screen Missing

MISSING SCREEN

MASTER CLOSET WINDOW

A window is missing an insect screen. Recommend replacement.

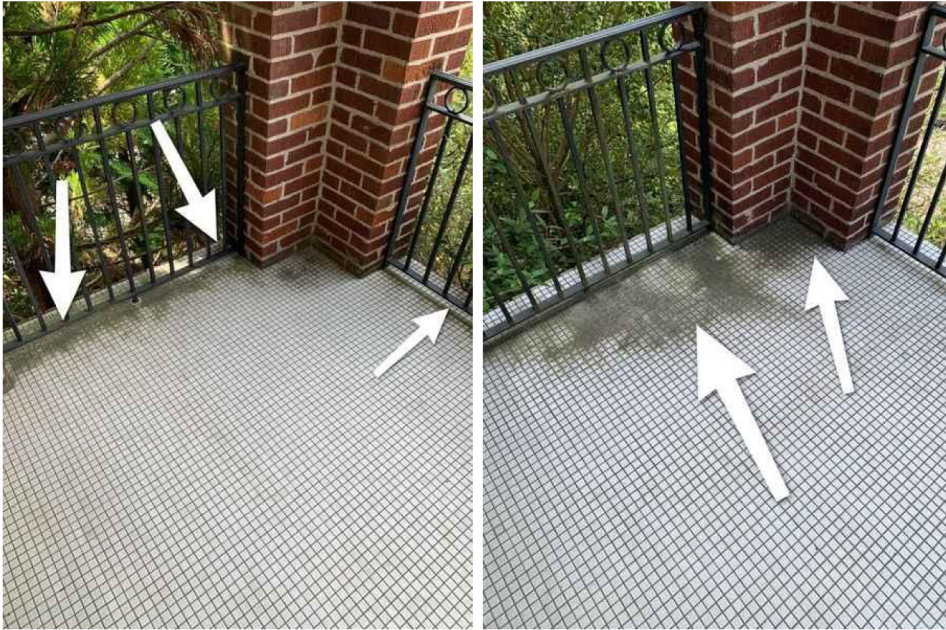
Signs of Ponding

EVIDENCE OF PONDING

Biological growth on the exposed tile is evidence of water ponding on the finish surface of the porch causing discoloration. Frequent maintenance may be required. Exterior conditions should be monitored under storm conditions.

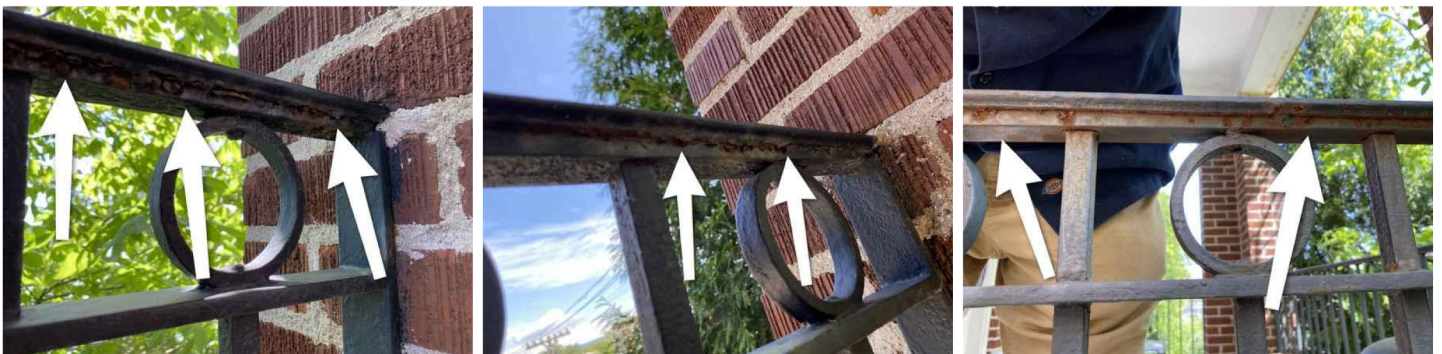
3.4.2 Covered Porches

HANDRAIL RUSTING

Steel Alloy Graspable Handrail is rusting where one would grab it. It has de-laminated the steel enough to create a cut hazard. Recommend a qualified metal handrail contractor evaluate to repair or replace. Rust will eventually destroy the stability of metal handrails.

Contact a qualified professional.

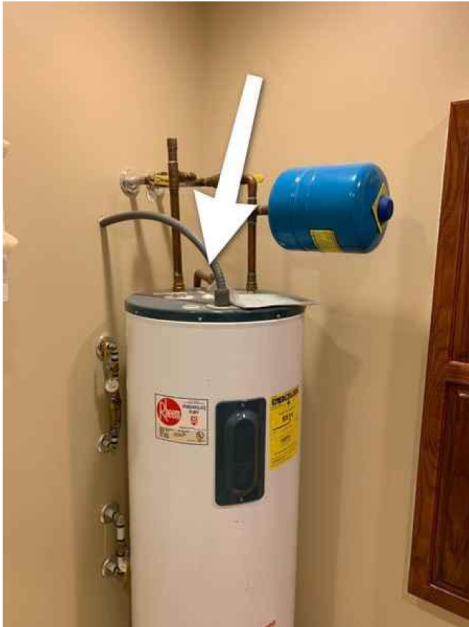
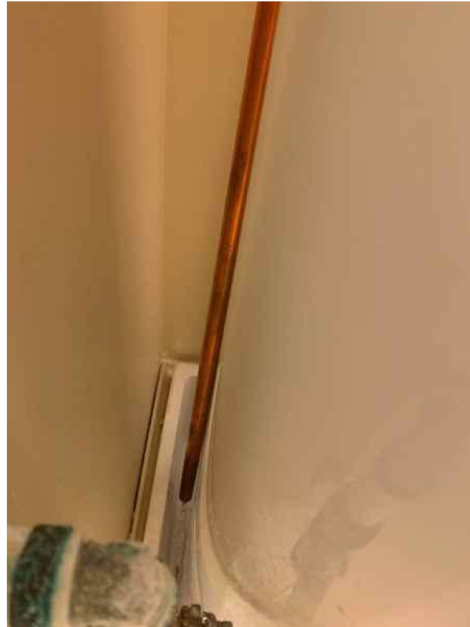
Hot Water Heater TPR Valve Discharge

TPR VALVE DISCHARGE NOT VISIBLE

LAUNDRY ROOM

The discharge port of the TPR Valve should be easily observable at all times. It should be checked frequently for signs of discharge. Recommend a qualified plumbing contractor relocate the discharge pipe to a more conspicuous location.

Contact a qualified plumbing contractor.

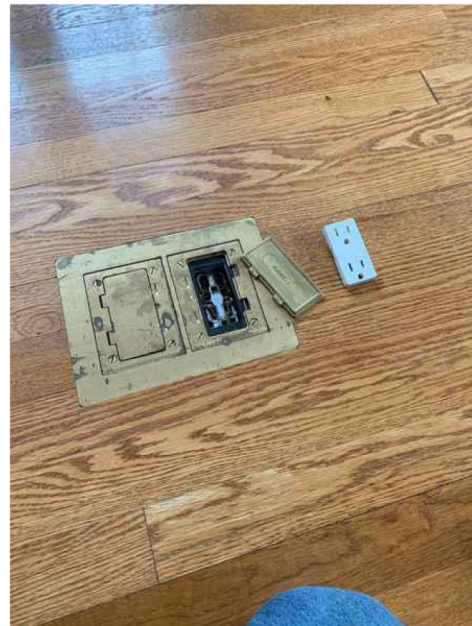
Broken Floor Outlet

FLOOR OUTLET BROKEN

LIVING ROOM

The Brass cover and face of receptacle are broken. The face of the outlet pops off, exposing the contacts of the receptacle. The brass cover is broken off at the hinges, and rests in place. Recommend a qualified electrician rewire a new floor outlet and box.

Contact a qualified electrical contractor.

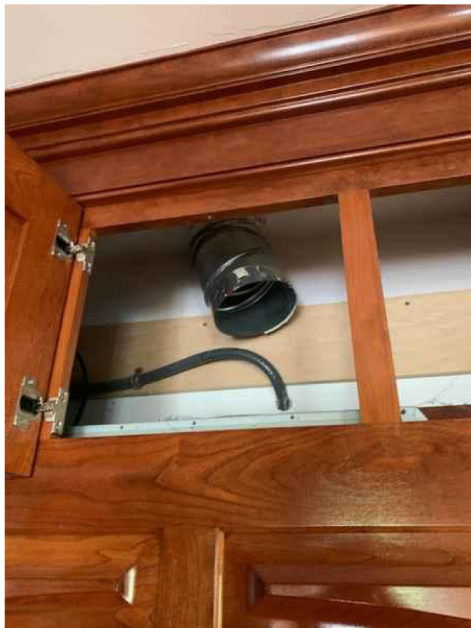
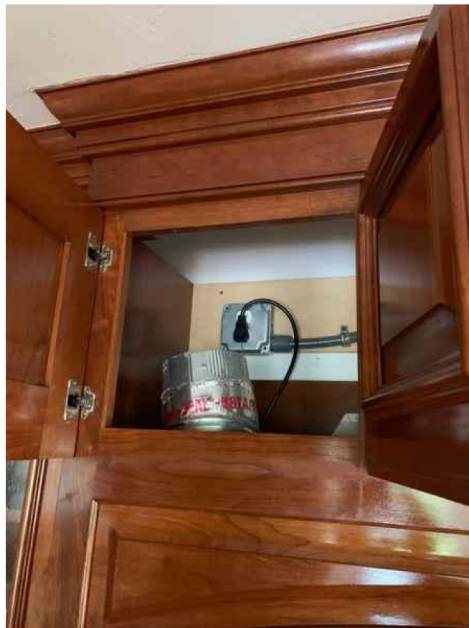
9.4.1 Range

EXHAUST DUCT TERMINATES IN CABINET

Exhaust from range hood terminates into the cabinet. This can result in moisture damage and mold in the cabinet. Recommend a qualified carpentry or HVAC contractor re-route this duct to terminate properly.

Contact a qualified HVAC professional.
